# Evaluation of Drinking Water Quality and Bacterial Antibiotic Sensitivity in Wells and Standpipes at Household Water Points in Freetown, Sierra Leone

**Abstract:** Water quality surveillance can help to reduce waterborne diseases. Despite better access to safe drinking water in Sierra Leone, about a third of the population (3 million people) drink water from unimproved sources. In this cross-sectional study, we collected water samples from 15 standpipes and 5 wells and measured the physicochemical and bacteriological water quality, and the antimicrobial sensitivity of *Escherichia coli* (*E. coli*) in two communities in Freetown, Sierra Leone in the dry and wet seasons in 2021. All water sources were contaminated with *E. coli*, and all five wells and 25% of standpipes had at least an intermediate risk level of *E. coli*. There was no antimicrobial resistance detected in the *E. coli* tested. The nitrate level exceeded the WHO's recommended standard (>10 parts per million) in 60% of the wells and in less than 20% of the standpipes. The proportion of samples from standpipes with high levels of total dissolved solids (>10 Nephelometric Turbidity Units) was much higher in the rainy

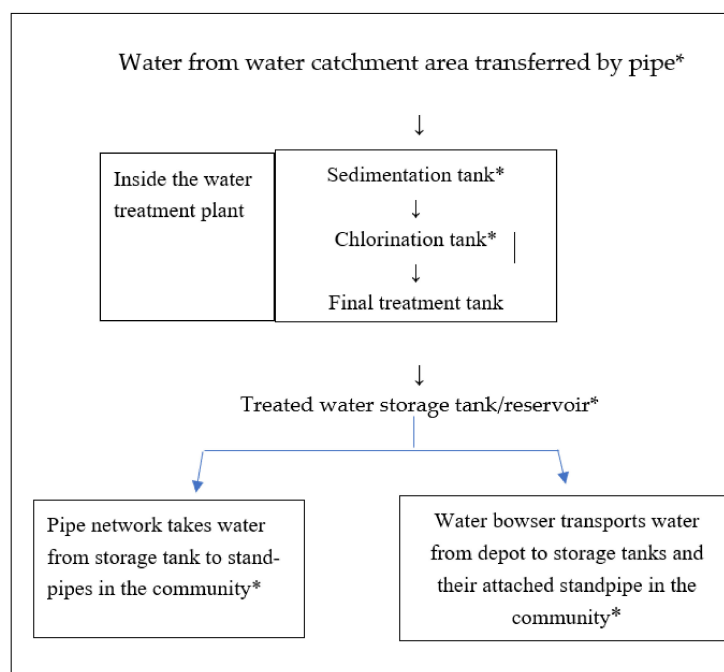
**Figure 1.** Flow diagram of water travelling from the catchment area of public water company to standpipes in Freetown Sierra Leone and the stages at which the water samples were taken. \* indicates where water samples were taken.

The flow diagram of the public water company (see Figure 1) depicts the water traveling from the water catchment area to the sedimentation tank, and then onward to the chlorination tank, the final treatment tank, the storage tank or reservoir, and finally through the distribution networks either to standpipes connected to the water company's pipe network or by transportation via water bowser to the storage tank with standpipes connected to storage tanks of 10,000 L capacity.

To measure the water quality delivered from the water company through the standpipes, water was sampled at four points as the water passed progressively through the water treatment plant, the final sample being taken at the outflow after purification treatment. Samples were then taken from the 15 standpipes: eight in Brookfields and seven in Wilberforce. Water was also sampled from the five community wells in both Brookfields and Wilberforce. This gave a total of 48 samples that were collected, 24 in each season. Distilled water was used to clean the pipette, thermometer, pH meter and turbidity meter between measurements. Collected water samples were transported on an icepack to the Milton Margai Technical University Laboratory (MMTU) for laboratory analysis.

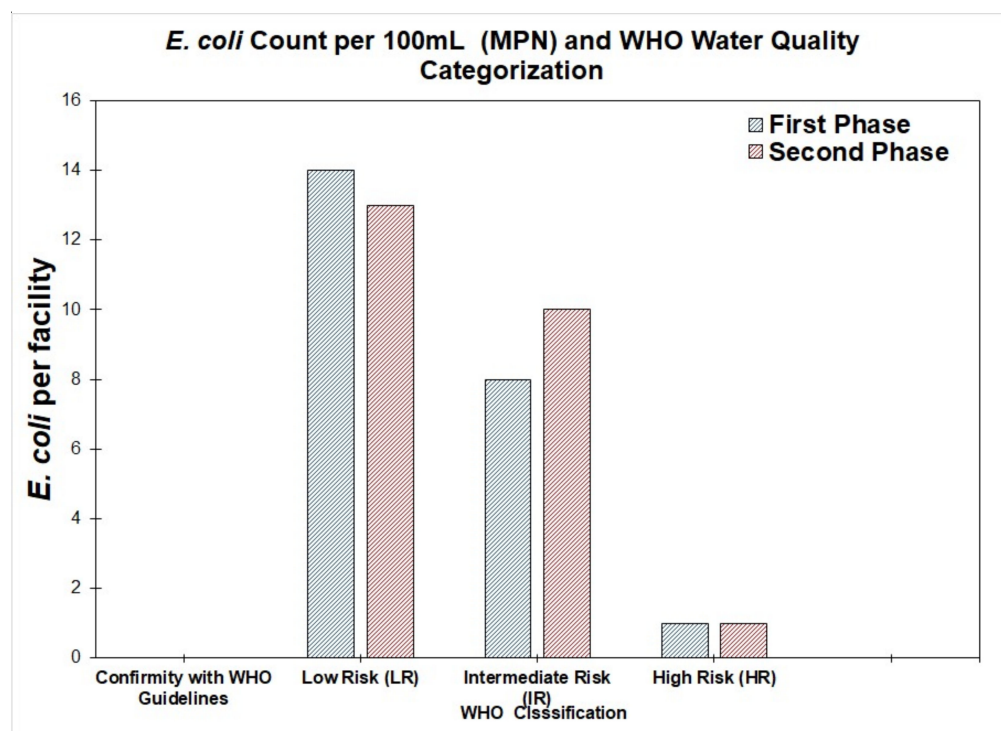
**Figure 3.** *E. coli* count per 100 mL according to the WHO standard *E. coli* classification for the first and second phase sample collections.

All the samples from standpipes were assessed for the presence of *E. coli* using the MPN method (Table 3). All these water samples were contaminated with *E. coli* at least at a low risk level (1–10 MPN/100 mL) of *E. coli*. The proportion of the samples that contained *E. coli* at an intermediate risk level (10–100 MPN/100 mL) or above varied from 20% to 33% (see Figure 3), although the standpipes connected to the network pipes did not show any more than a low risk of *E. coli*. The number of standpipes directly connected to the pipe network was too small a sample to confirm the significance of this finding. There was no association between finding *E. coli* in a sample and the geographical location or season of the year.

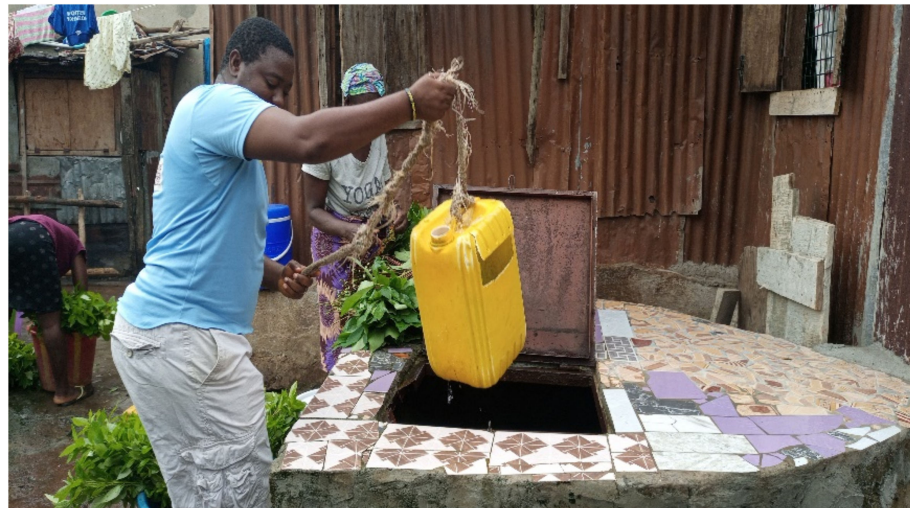
**Figure 4.** Sources of contamination at a well. Leafy vegetables are washed on top of the well, and that same water may drain back into the well. While the woman washes the vegetables, the man fetches water using a plastic container hung from a rope. The lid or cover is also prone to corrosion as it is made of iron and can be another potential source of contamination.

One of the ways drinking water sources from wells are contaminated are shown in Figure 4. Drinking water were tested for pH, and TDS connected to a 10,000 L capacity standpipe (see Figure 5), and Figure 6 depicted a standpipe connected to a pipe network.

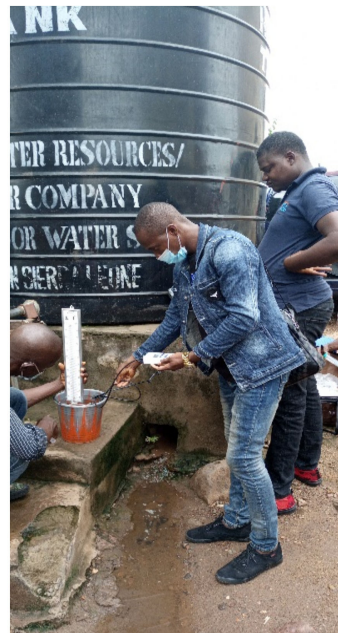
**Figure 5.** Physical testing of a standpipe connected to a storage tank. A standpipe connected to a storage tank (10,000 L capacity) depicts physical testing of the pH of the water and total dissolved solids using pH meter and turbidimeters.

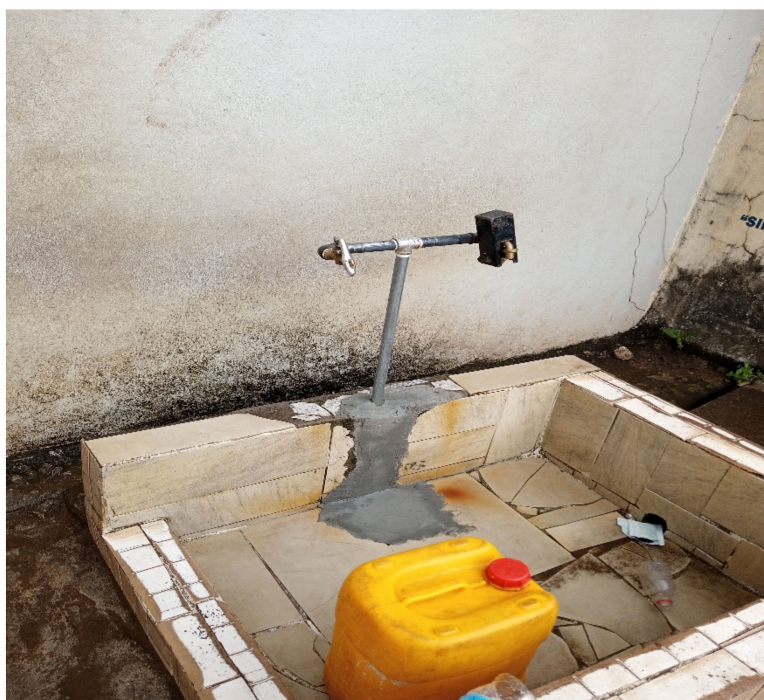
**Figure 6.** A typical example of one of the standpipes in Brookfields connected to the pipe network. The tap is closed after use by the people.
